Date: 24<sup>th</sup> January 2024

# TECH TOOL RELEASE NOTES

Version 2.8.231

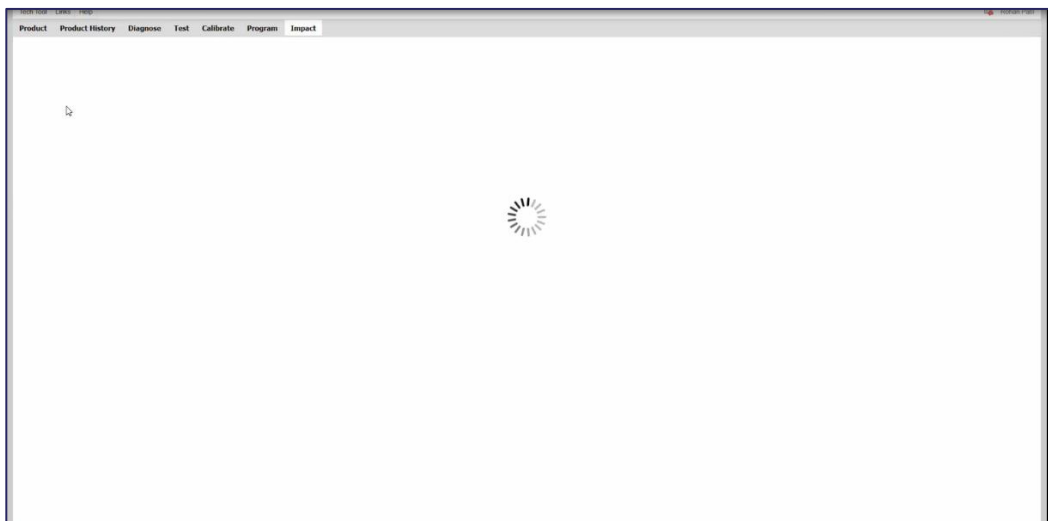
### **Issue-1: The Impact tab might not load and will be frozen.**

**Cause:** Impact application.

**Suggestion:** Kindly follow the below steps:

1. Launch Impact tab standalone application from Browser.
2. Enter the chassis information and select "Repair" as Info Type.
3. Select "Titles" under Search by and enter the search criteria.

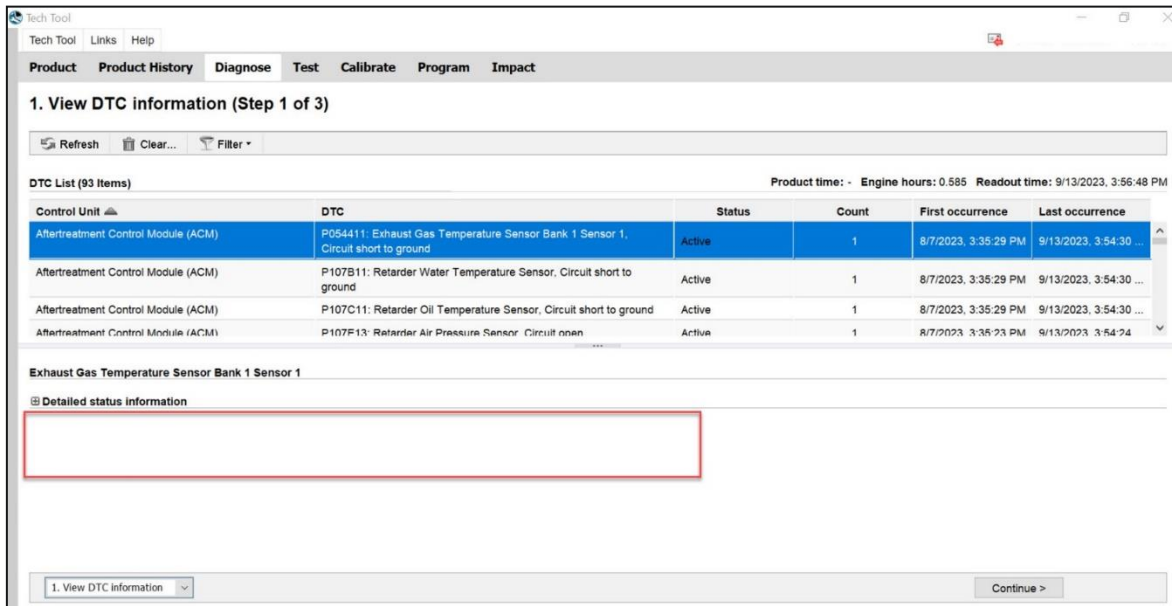
### **Issue-2: Freeze frame information is missing from Diagnose tab.**

**Cause:** Under Investigation.

**Suggestion:** No workaround available.

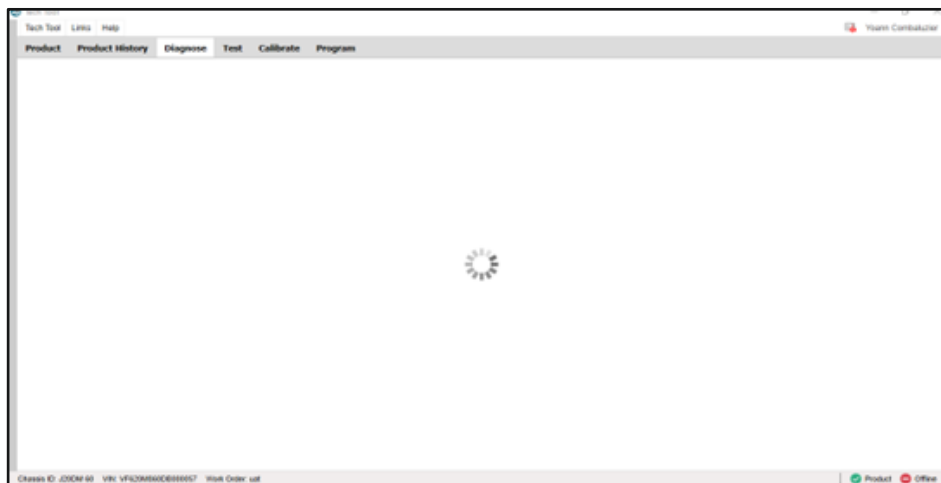
### **Issue-3: While switching between the tabs, Tech Tool might be frozen.**

**Cause:** Under Investigation.

**Suggestion:** Kindly follow the below steps:

1. Ensure that there is a stable network as shown in the icon

2. Restart Tech Tool.
3. If not able to recover, restart the computer.

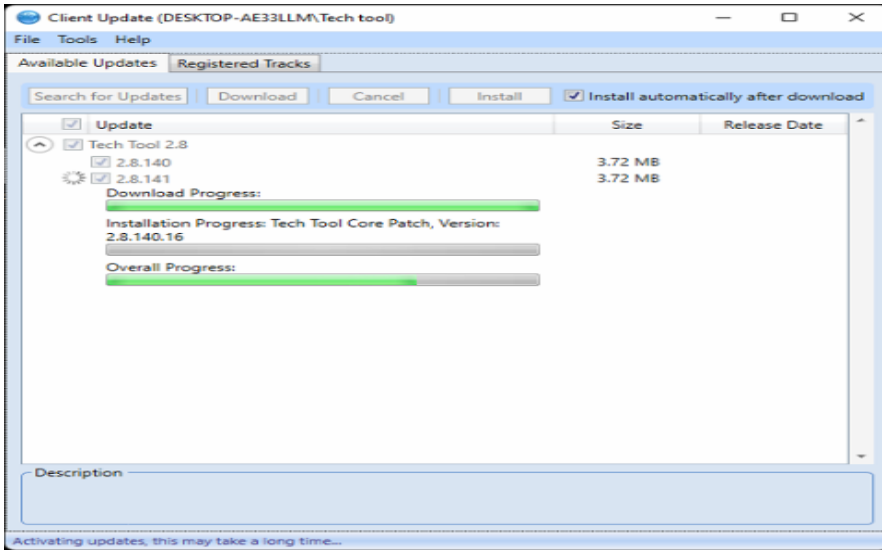
### **Issue-4: Tech Tool installation progress bar is frozen during Client Update.**

**Cause:** Under Investigation

**Suggestion:** Restart computer if the progress bar is frozen.

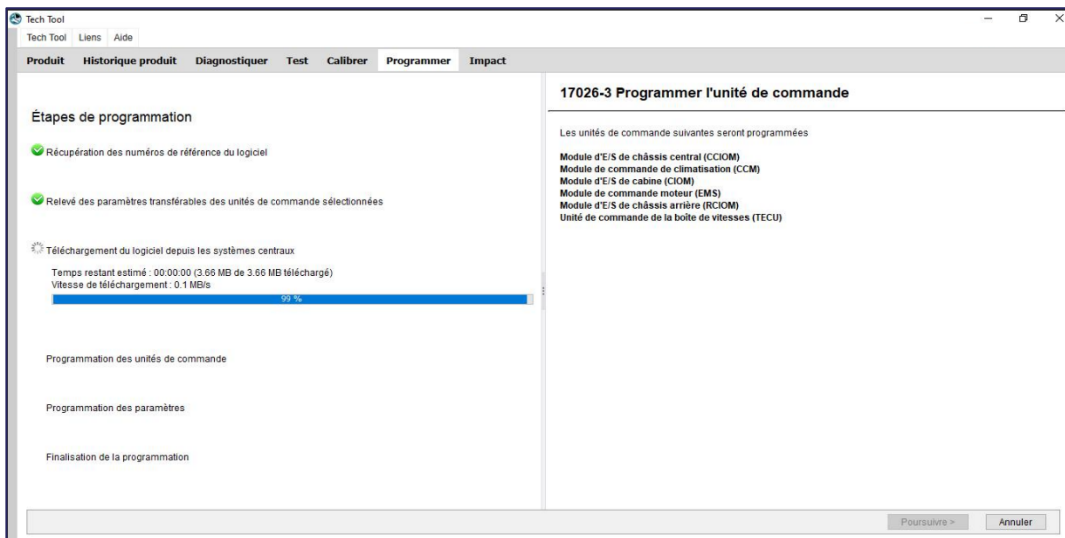
### **Issue-5: While programming, the software download might get stuck at 99%.**

**Cause:** Under Investigation.

**Suggestion:** Use Quick Repair tool to resolve this issue. Refer [Video](#).
