Date: 19<sup>th</sup> March 2024

# TECH TOOL RELEASE NOTES

Version 2.8.241

**Volvo Group**

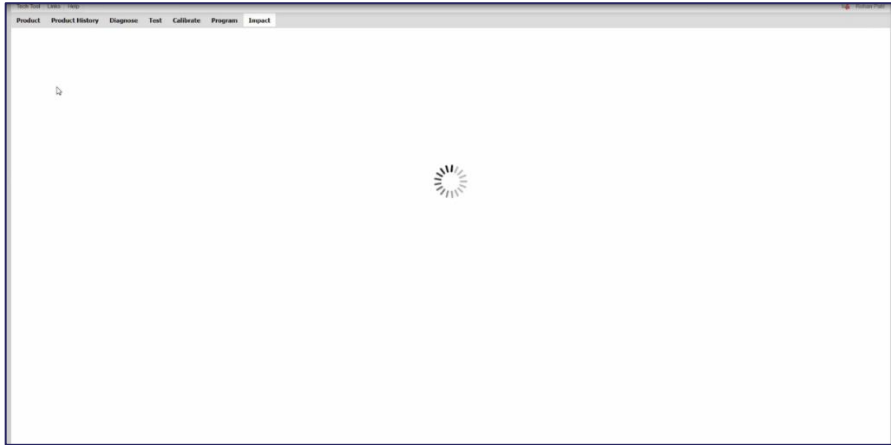
**Issue-1: The Impact tab might not load and will be frozen.**

**Cause:** Impact application.

**Suggestion:** Kindly follow the below steps:

1. Launch Impact tab standalone application from Browser.
2. Enter the chassis information and select "Repair" as Info Type.
3. Select "Titles" under Search by and enter the search criteria.

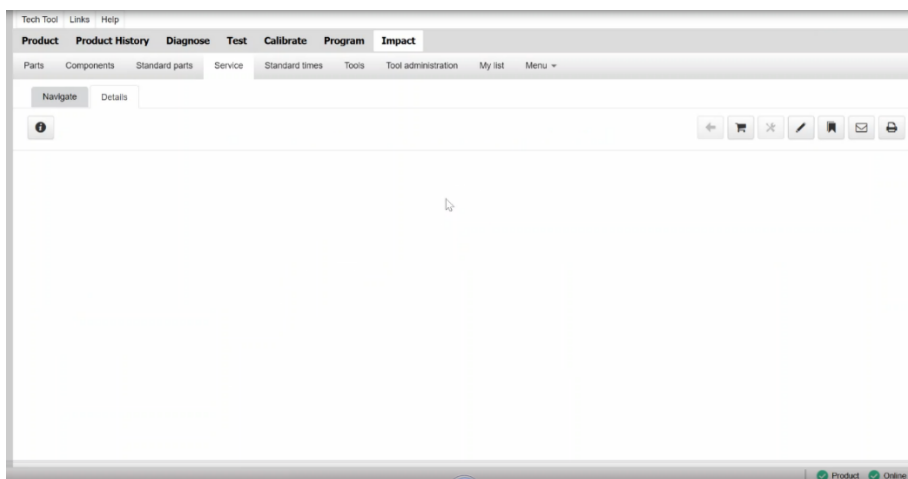
**Issue-2: The Impact tab will not load data when loading from service links.**

**Cause:** Impact application.

**Suggestion:** Kindly follow the below steps:

1. Launch Impact tab standalone application from Browser.
2. Enter the chassis information and select "Repair" as Info Type.
3. Select "Titles" under Search by and enter the search criteria.

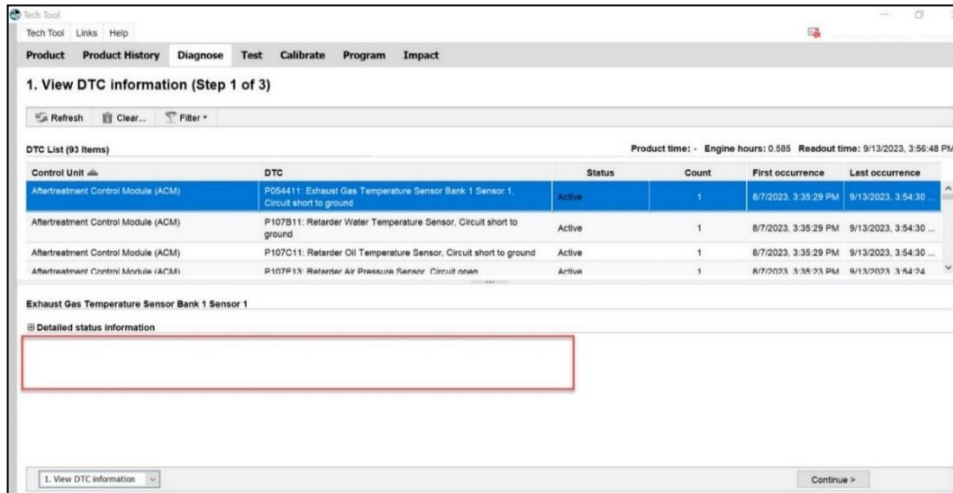
### **Issue-3: Freeze frame information is missing from Diagnose tab.**

**Cause:** Under Investigation.

**Suggestion:** No workaround available.

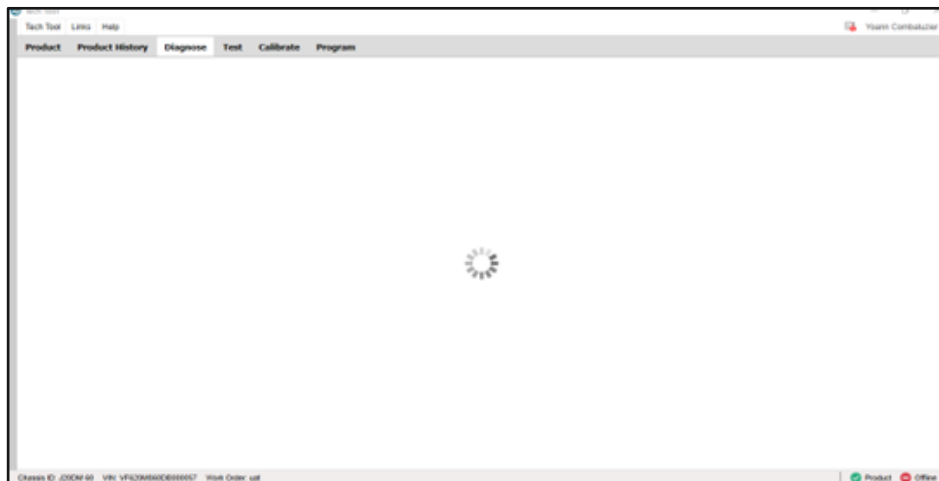
### **Issue-4: While switching between the tabs, Tech Tool might be frozen.**

**Cause:** Under Investigation.

**Suggestion:** Kindly follow the below steps:

1. Ensure that there is a stable network as shown in the icon

2. Restart Tech Tool.
3. If not able to recover, restart the computer.

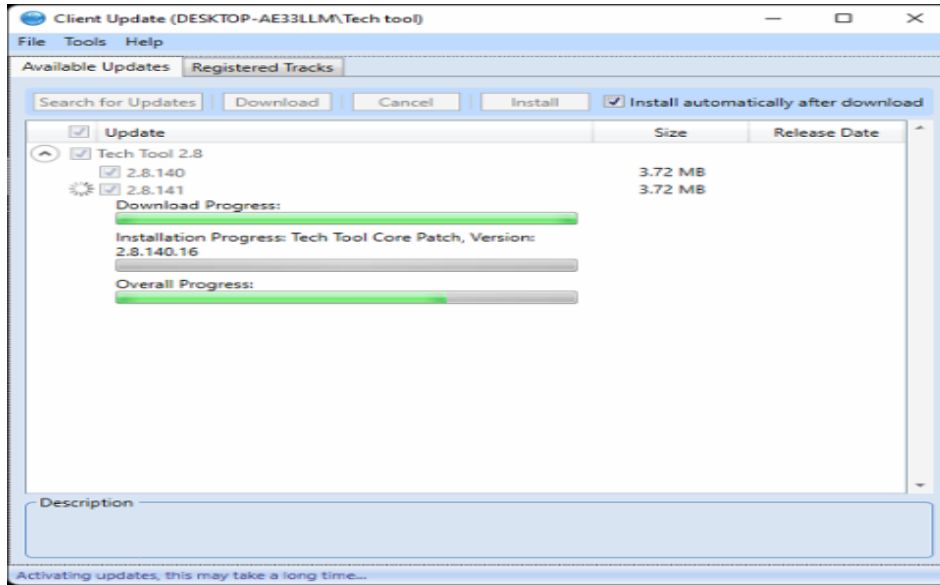
### **Issue-5: Tech Tool installation progress bar is frozen during Client Update.**

**Cause:** Under Investigation

**Suggestion:** Restart computer if the progress bar is frozen.

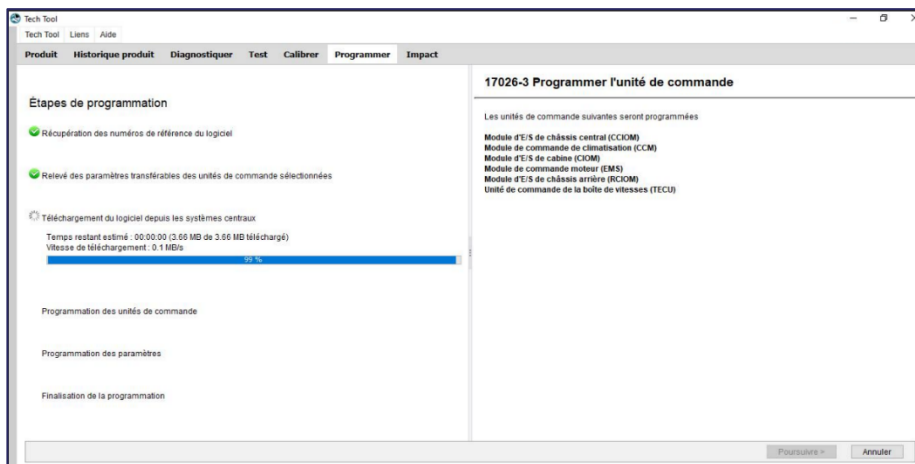
### **Issue-6: While programming, the software download might get stuck at 99%.**

**Cause:** Under Investigation.

**Suggestion:** Use Quick Repair tool to resolve this issue. Refer [Video](#).
