Date: 17th April 2024

TECH TOOL RELEASE NOTES

Version 2.8.250

Volvo Group

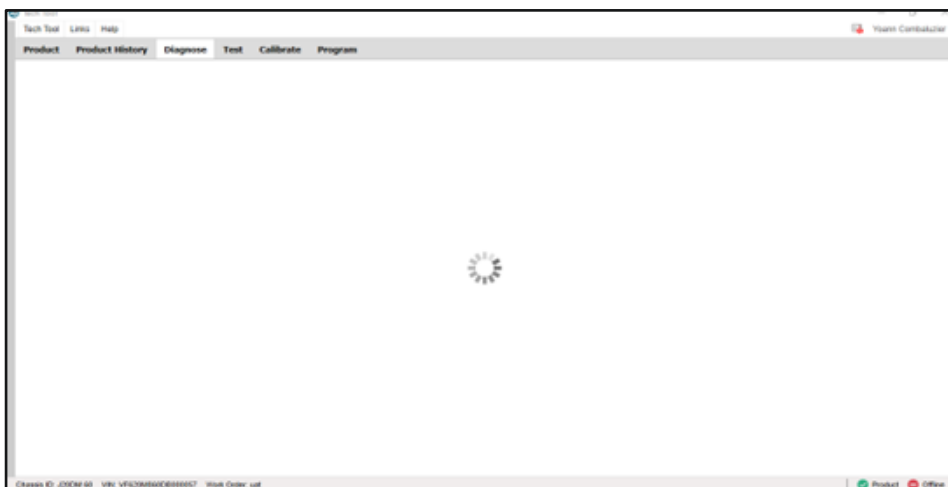
Issue-1: Tech Tool might take more time to load tabs (Diagnose, Test, Calibrate, Program).

Cause: Under Investigation

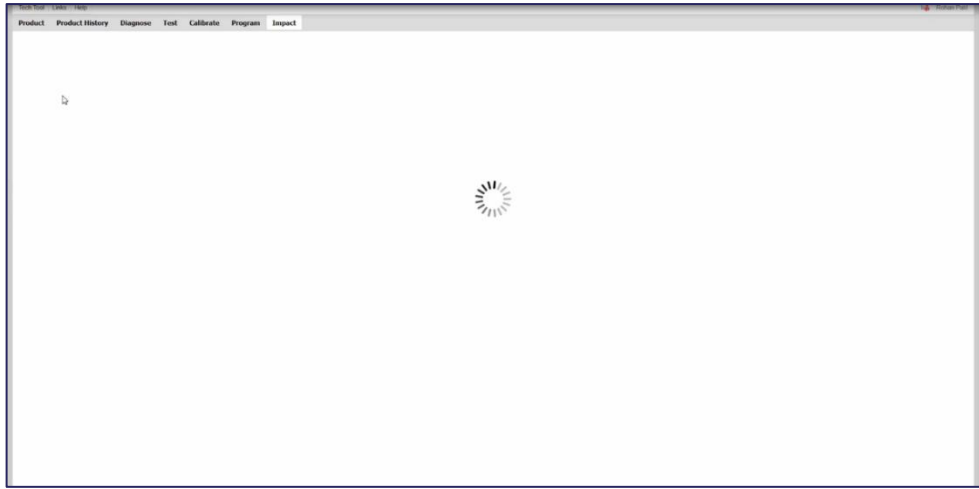
Issue-2: The Impact tab might not load and will be frozen.

Cause: Impact application.

Suggestion: Kindly follow the below steps:

1. Launch Impact tab standalone application from Browser.
2. Enter the chassis information and select "Repair" as Info Type.
3. Select "Titles" under Search by and enter the search criteria.

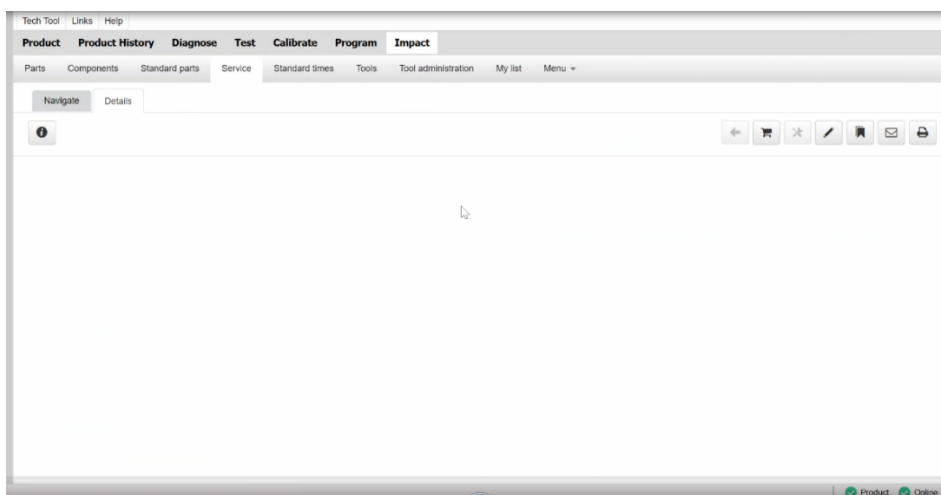
Issue-3: The Impact tab will not load data when loading from service links.

Cause: Impact application.

Suggestion: Kindly follow the below steps:

1. Ensure that there is a stable network as shown in the icon

2. Restart Tech Tool.
3. If not able to recover, restart the computer.

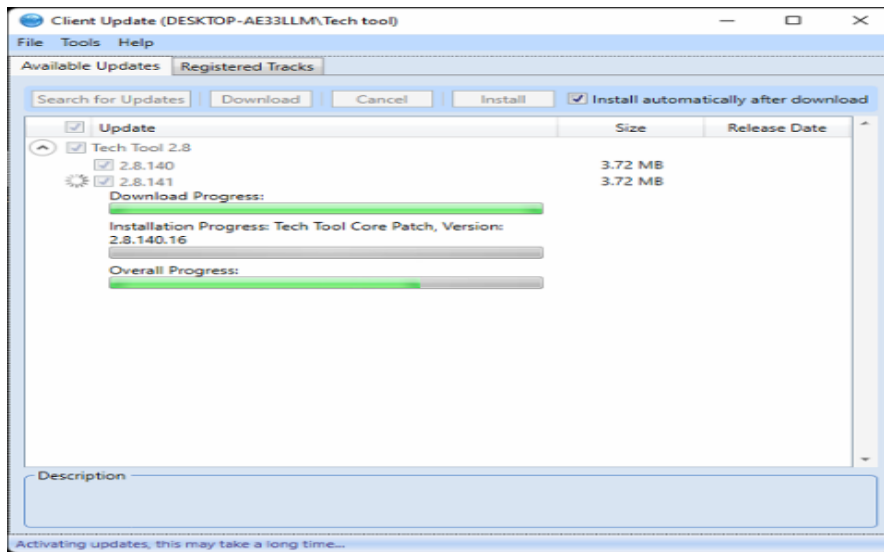
Issue-6: Tech Tool installation progress bar is frozen during Client Update.

Cause: Under Investigation

Suggestion: Restart computer if the progress bar is frozen.

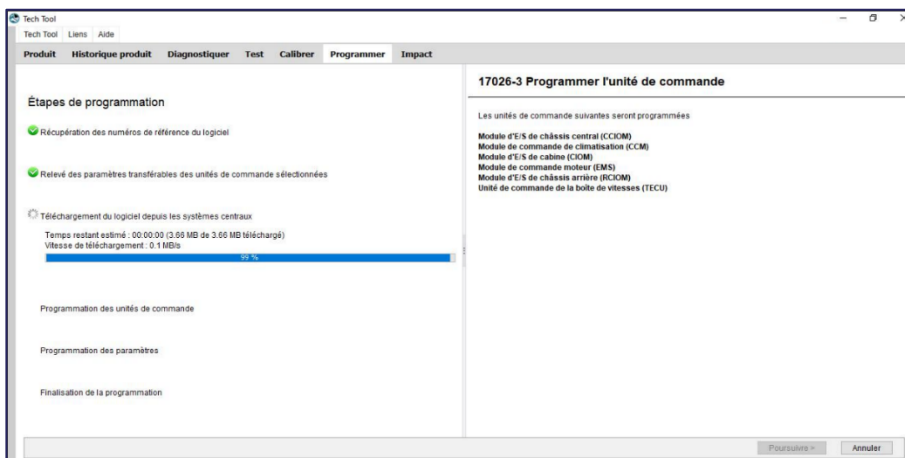
Issue-7: While programming, the software download might get stuck at 99%.

Cause: Under Investigation.

Suggestion: Use Quick Repair tool to resolve this issue. Refer [Video](#).
