Date: 30th May 2024

TECH TOOL RELEASE NOTES

Version 2.8.260

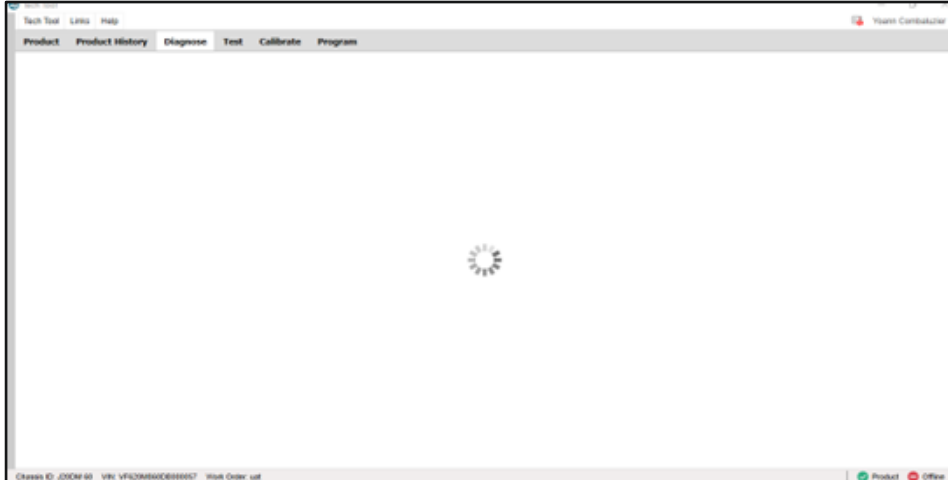
Issue-1: Tech Tool might take more time to load tabs (Diagnose, Test, Calibrate, Program).

Cause: Under Investigation

Suggestion: No workaround available.

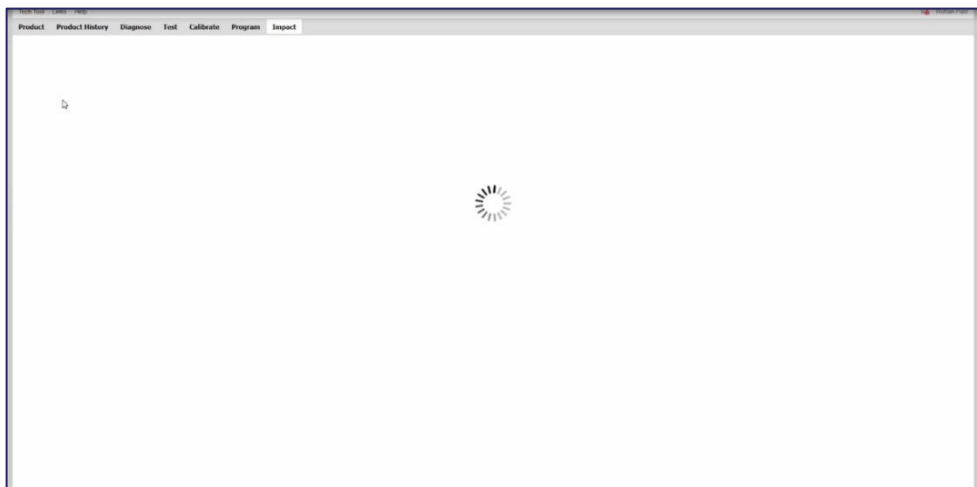
Issue-2: The Impact tab might not load and will be frozen.

Cause: Impact application.

Suggestion: Kindly follow the below steps:

1. Launch Impact tab standalone application from Browser.
2. Enter the chassis information and select "Repair" as Info Type.
3. Select "Titles" under Search by and enter the search criteria.

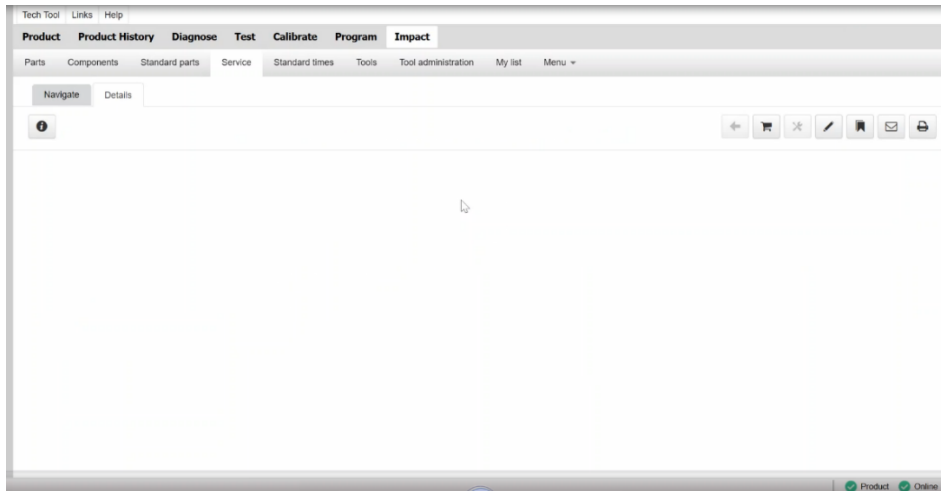
Issue-3: The Impact tab will not load data when loading from service links.

Cause: Impact application.

Suggestion: Kindly follow the below steps:

- 1. Launch Impact tab standalone application from Browser.
- 2. Enter the chassis information and select "Repair" as Info Type.
- 3. Select "Titles" under Search by and enter the search criteria.

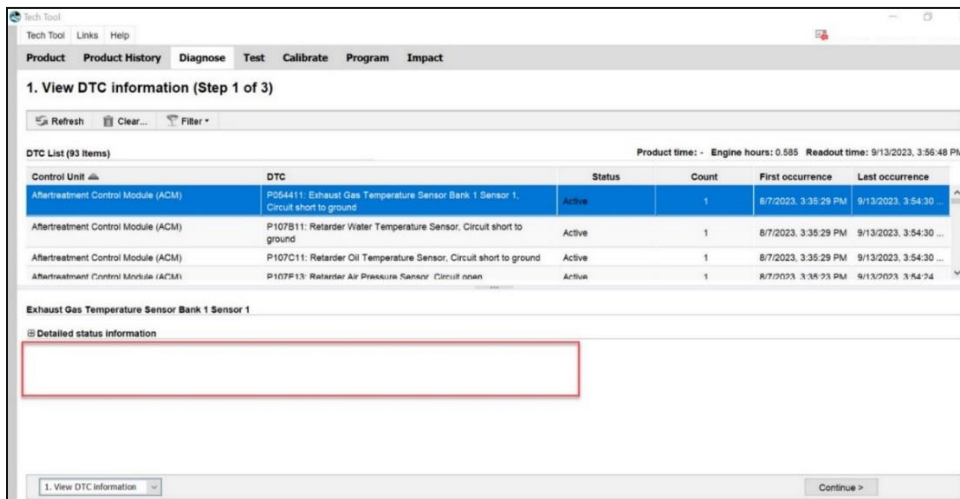
Issue-4: Freeze frame information is missing from Diagnose tab.

Cause: Under Investigation.

Suggestion: No workaround available.

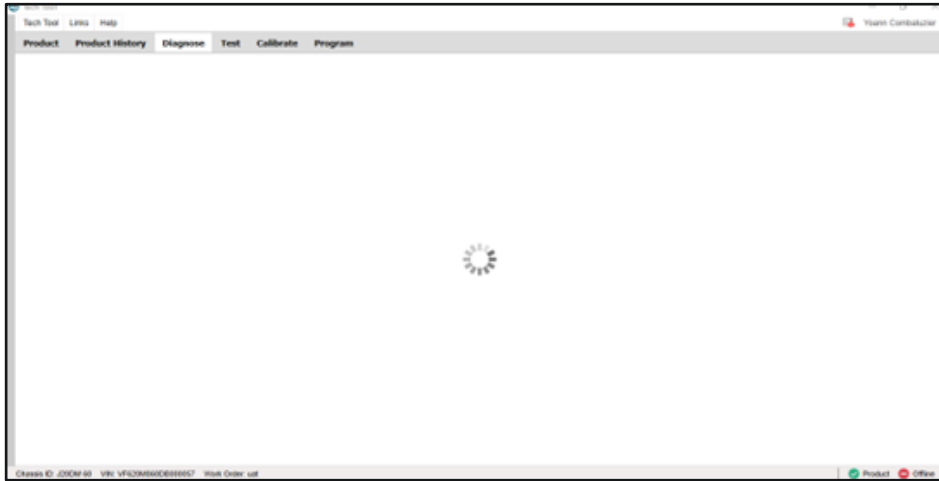
Issue-5: While switching between the tabs, Tech Tool might be frozen.

Cause: Under Investigation.

Suggestion: Kindly follow the below steps:

1. Ensure that there is a stable network as shown in the icon

2. Restart Tech Tool.
3. If not able to recover, restart the computer.

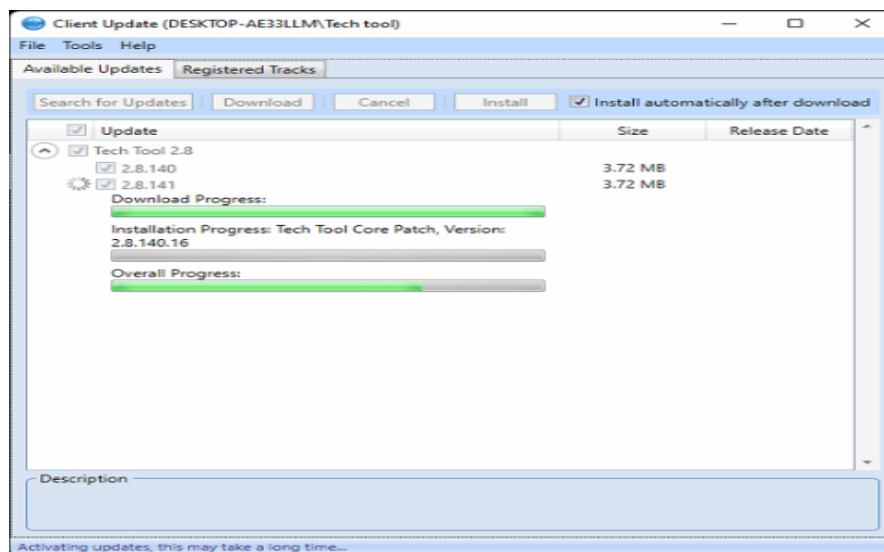
Issue-6: Tech Tool installation progress bar is frozen during Client Update.

Cause: Under Investigation

Suggestion: Restart computer if the progress bar is frozen.

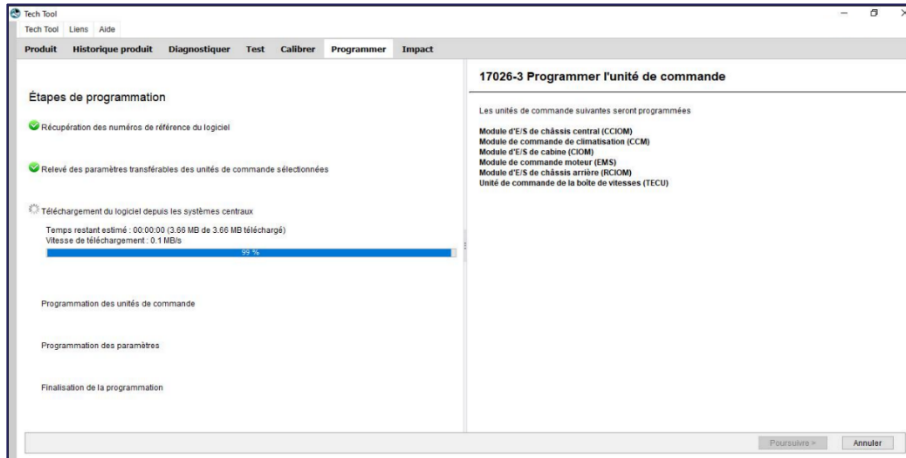
Issue-7: While programming, the software download might get stuck at 99%.

Cause: Under Investigation.

Suggestion: Use Quick Repair tool to resolve this issue. Refer [Video](#).
